HMS Hampshire 100

Survey Report

Location: Atlantic Ocean, waters west of Orkney, Scotland

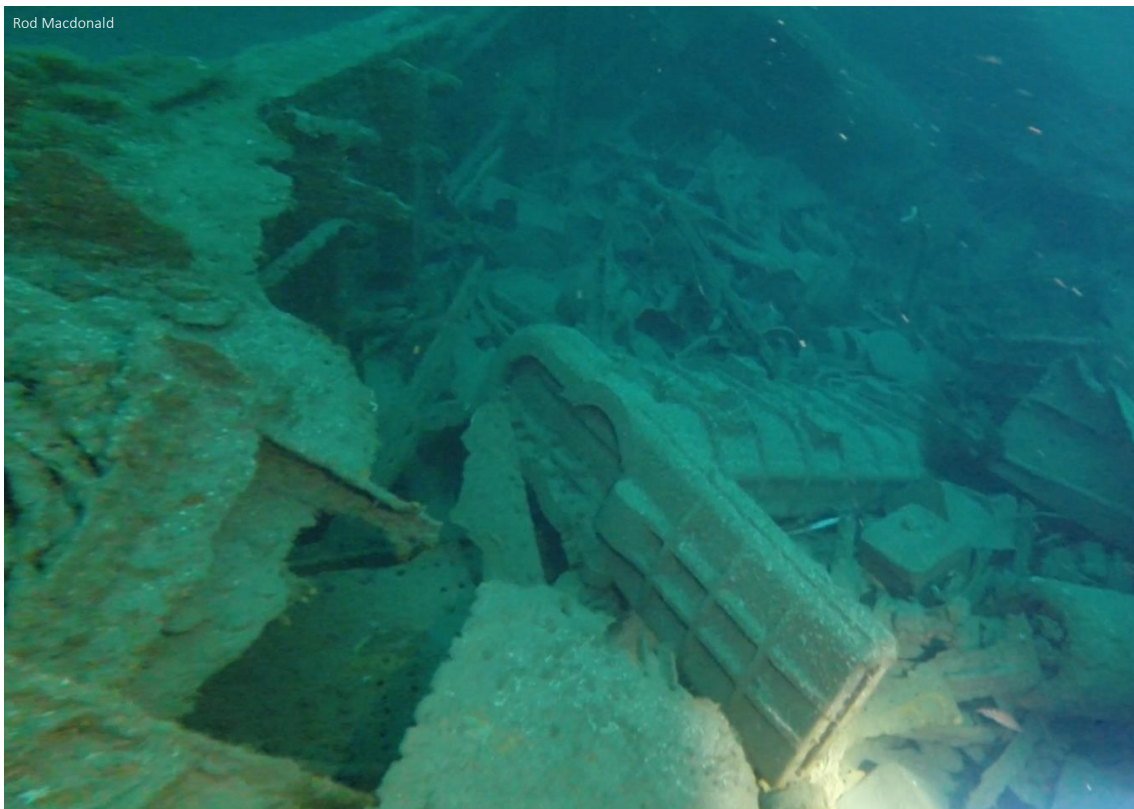
HMS HAMPSHIRE's two lateral submerged torpedo tubes were positioned on the Platform Deck between frame Nos 33 and 37. The starboard torpedo tube lies in the damaged area of the bow in the approximate correct longitudinal position, although it now rests lower in the wreckage. The tube appears complete and undamaged with the inner torpedo door attached. On the seabed the outer door is visible in severed hull plating to starboard. The port side tube was not located during the survey. The port side tube outer door, however, remains in situ in the port hull plating. Intact torpedo warheads lie in the bow wreckage adjacent to the tube and a possible torpedo body lies outside the wreck, flush with the starboard side of the hull.

Figure 49: Looking forward towards the bow, the starboard torpedo tube can be seen in the debris

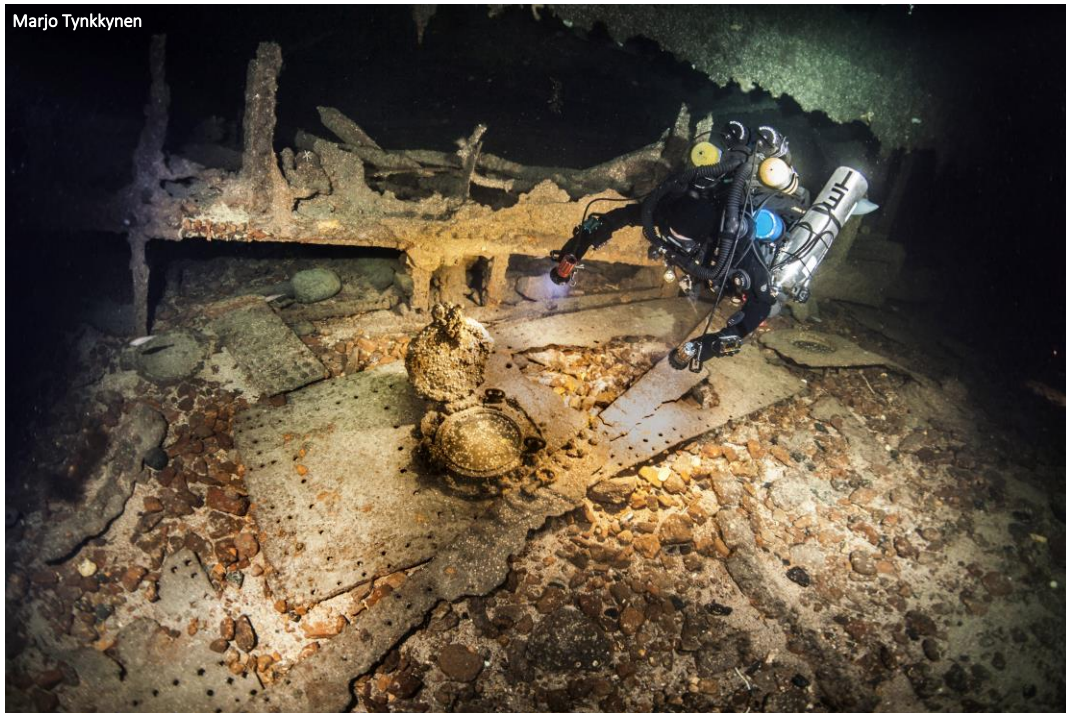
Figure 69: Starboard side Main Deck porthole, still located in the hull plating, now lies on the seabed with deadlight still open

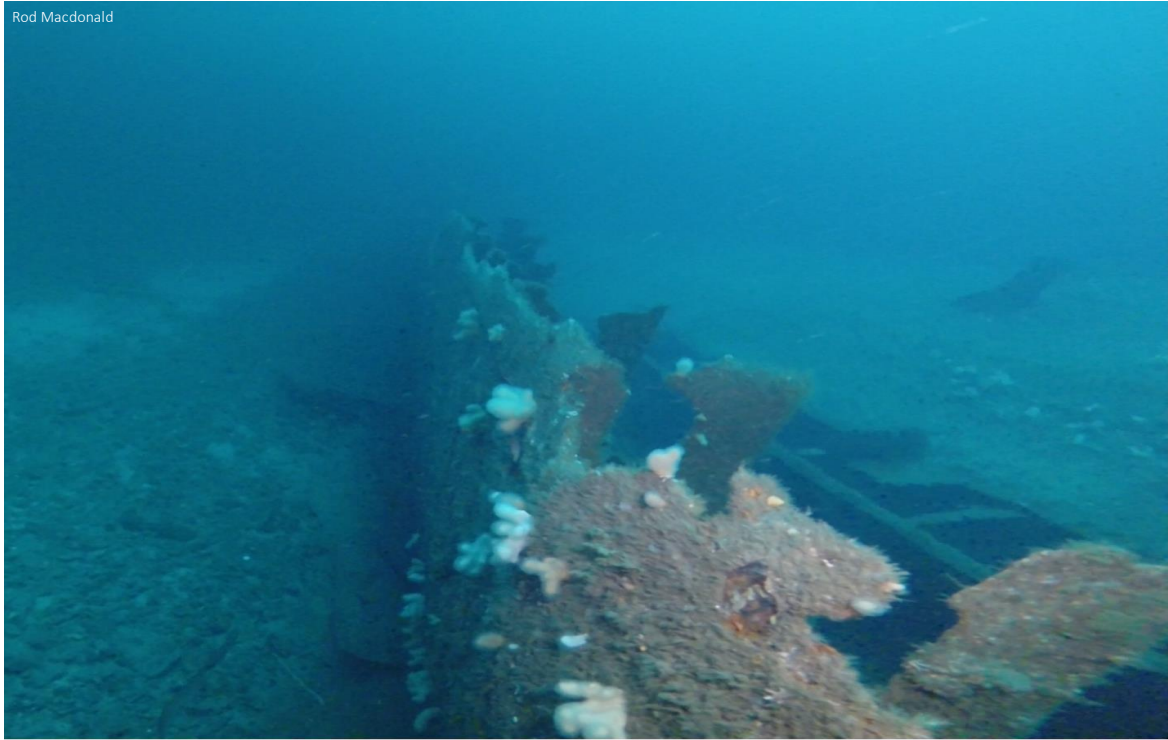
Figure 76: Looking forward along starboard side - fissure in the hull

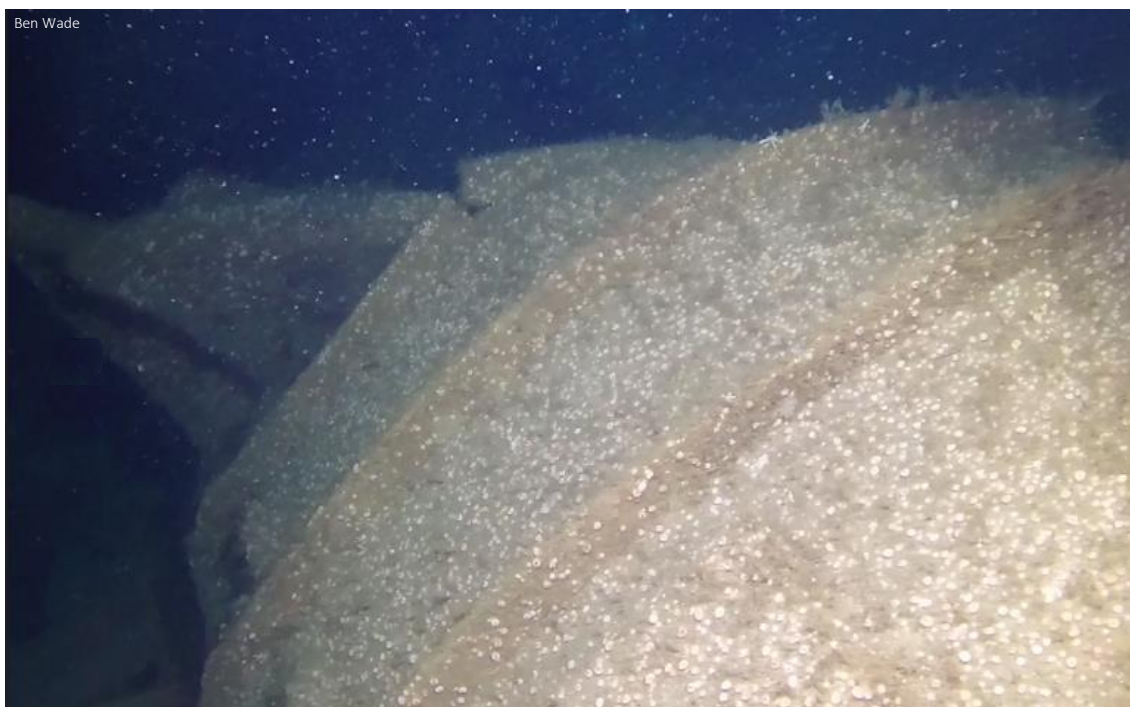
Figure 121: Bulkhead looking to port across the ship: note the cracking damage
